PINE GROVE DAM

PHASE I INSPECTION REPORT

NATIONAL DAM INSPECTION PROGRAM

AUGUST 1978

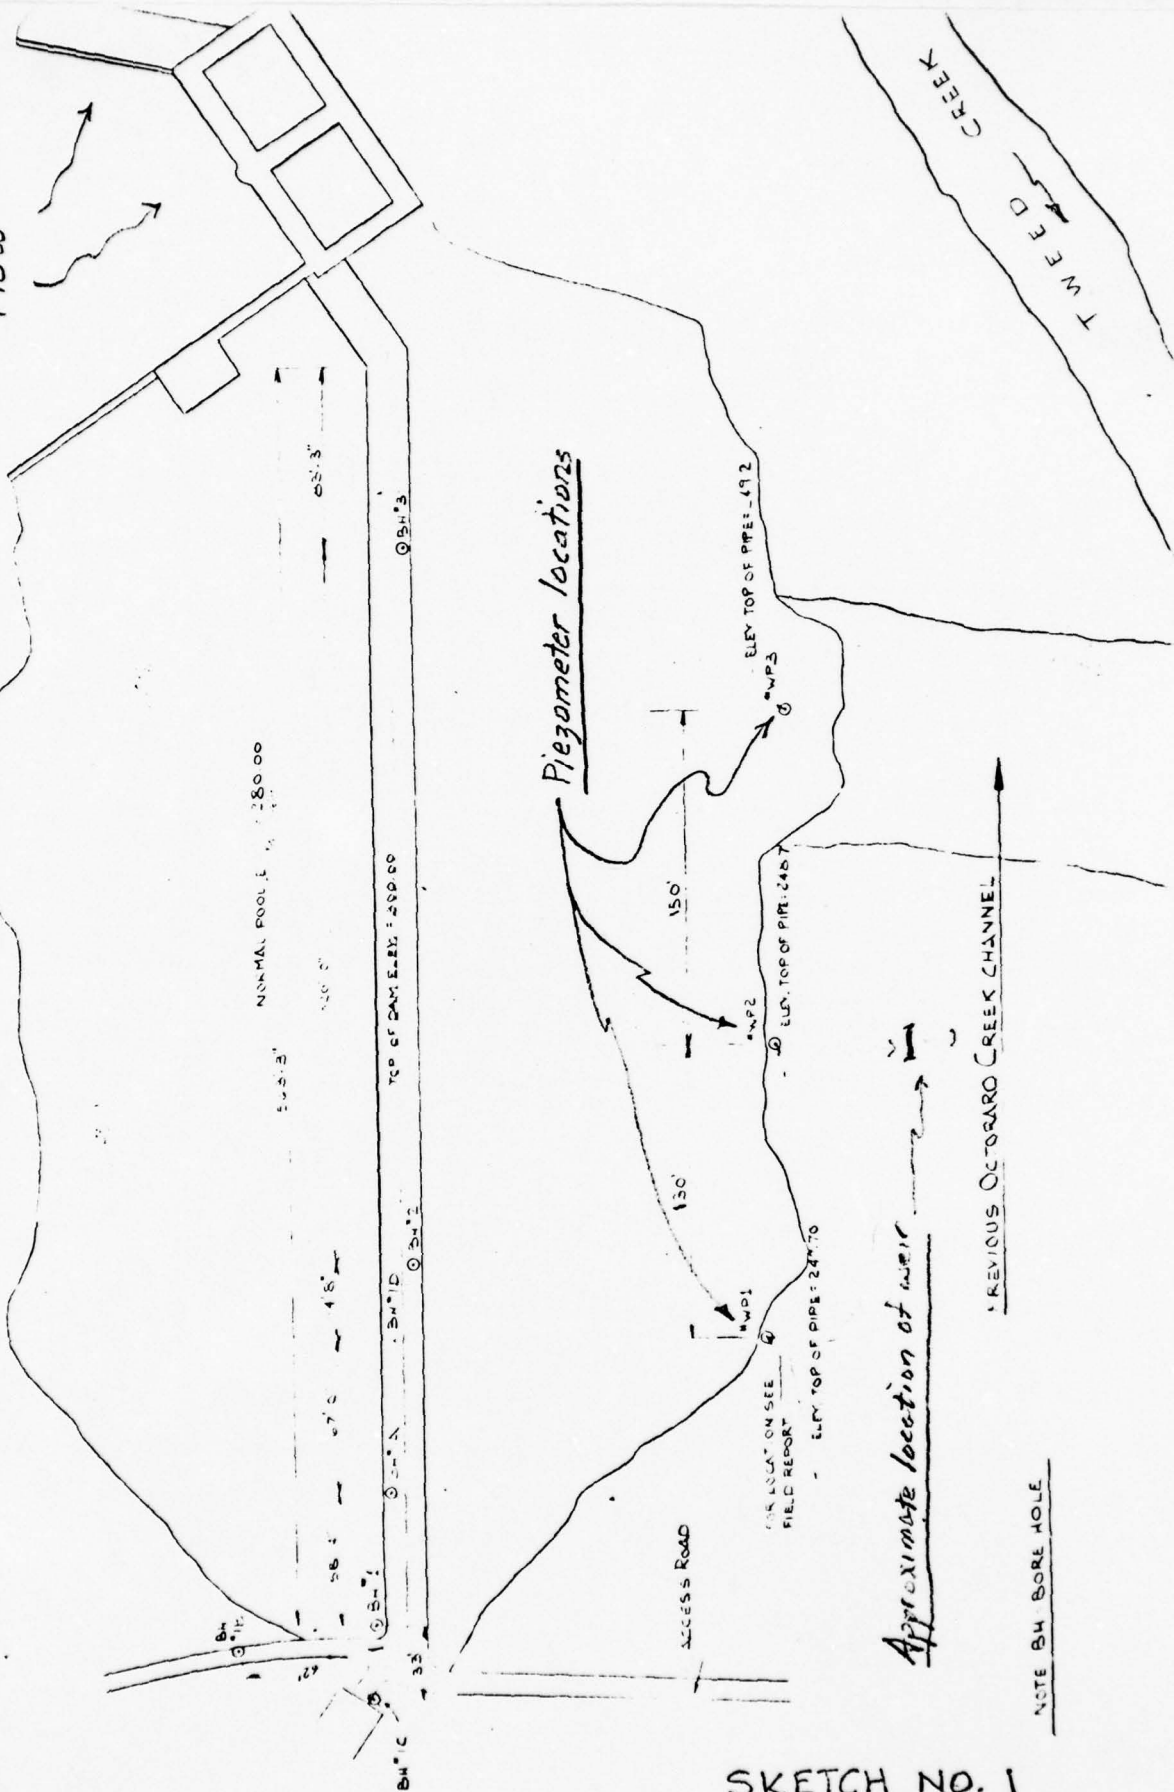
Piezometer locations

Approximate location of weir

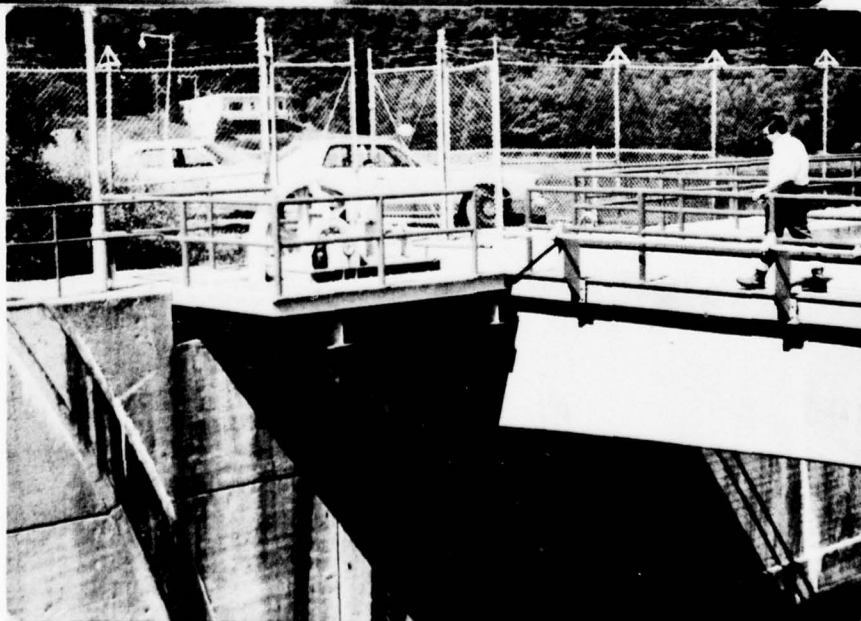
Two 44 feet wide by 30 feet high Tainter gates are located between the uncontrolled spillway and the left abutment of the embankment. The gates are operated by electrical power with a propane fueled engine as a standby power source. The gates can also be operated manually. Refer to Appendix D, Plates VI and V. Each gate was operated for observation at the time of this inspection. The total installation of the gate and controls is in good condition.

Chain of
Tainter Gate

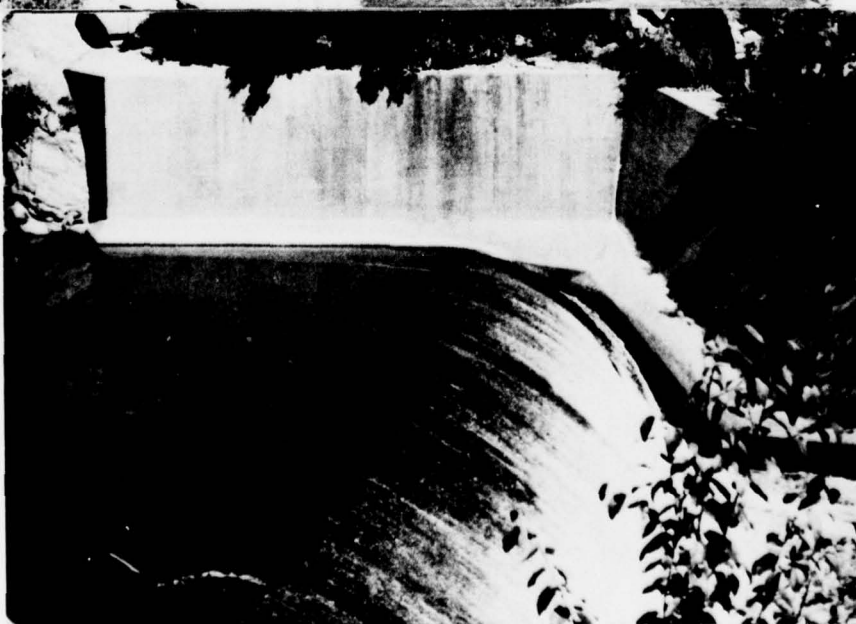
PLATE IV

The spillway is an uncontrolled concrete ogee section. Appendix D, Plate IV. The condition of the spillway is good. The spillway is at an angle of 80° with the axis of the dam. The left

abutment is tied into the natural rock and appears sound. The right abutment joins the left abutment of the Tainter gate structure and is also in good condition.

Spillway

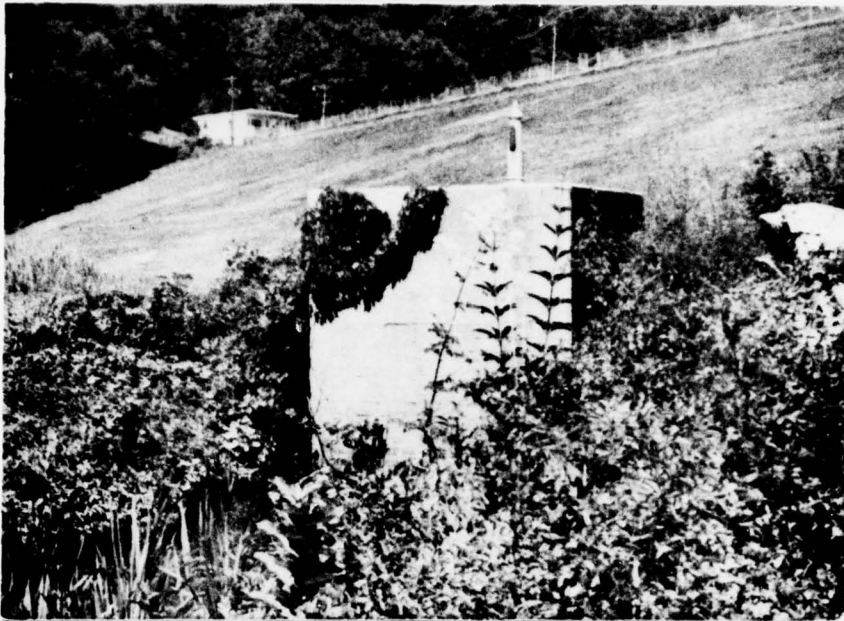
The outlet structure channel does not provide a positive outlet to the creek. It stops about 75 feet downstream from the outlet structure. This condition should be improved.

Conduit Outlet

The spillway, Tainter gates and intake structure all appear to be in good condition. The outlet structure channel should be continued downstream until it meets the natural stream.

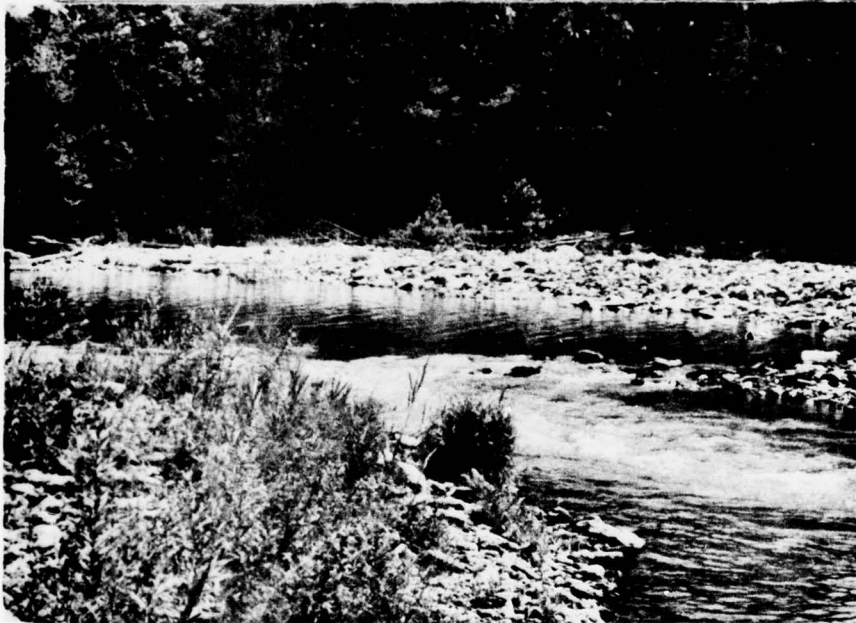
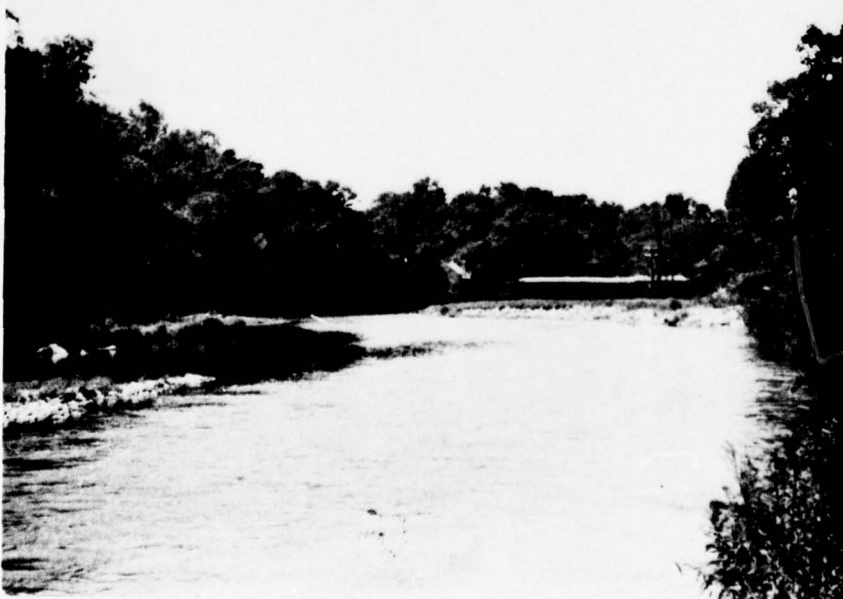
The downstream spillway outlet channel has been heavily eroded as a result of the 1972 tropical storm Agnes and other high discharge storms. Repairs to the dam side of the channel have been made and plans for additional protection of this condition are being considered by the owner.

The water discharging through the spillway has to make a sharp (90°) bend directly below the dam. Heavy erosion has occurred at the opposite hillside as a result of the 1972 tropical storm Agnes and other high runoff storms. Some repairs are being considered to improve this condition. A covered roadway bridge and a low dam cross the stream at a distance of about 1,500 feet below the dam. Aside from the treatment plant there are no residents along or in the flood plain for the next 10 miles. A developing mobile home area is located 10 miles from the dam. This area is adjacent to the stream in its flood plain and is subject to flooding and at the time of this inspection contained five mobile home units. It is expected that the additional loss of life due to dam failure after overtopping would be limited to a few and the additional economical loss would be appreciable. The hazard classification for this dam is considered to be "Significant".

Downstream
Channel
